INDOOR AIR QUALITY ASSESSMENT

**Wellesley High School
50 Rice Street
Wellesley, Massachusetts**

Prepared by:
Massachusetts Department of Public Health
Center for Environmental Health
Bureau of Environmental Health Assessment
Emergency Response/Indoor Air Quality Program
November 2004

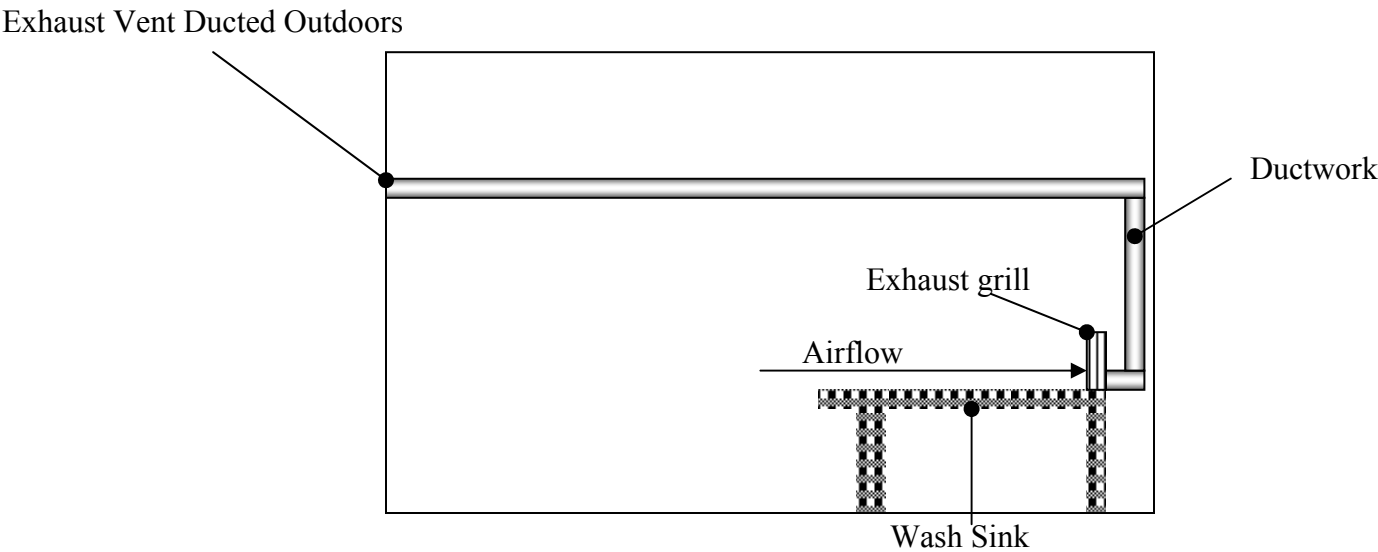
Figure 2

Suggested Reconfiguration of Dark Room Exhaust Ventilation

12. Repair the exhaust ventilation system in the darkroom. Operate the exhaust ventilation continuously to prevent the accumulation of photographic chemical odors in the darkroom of hallway.

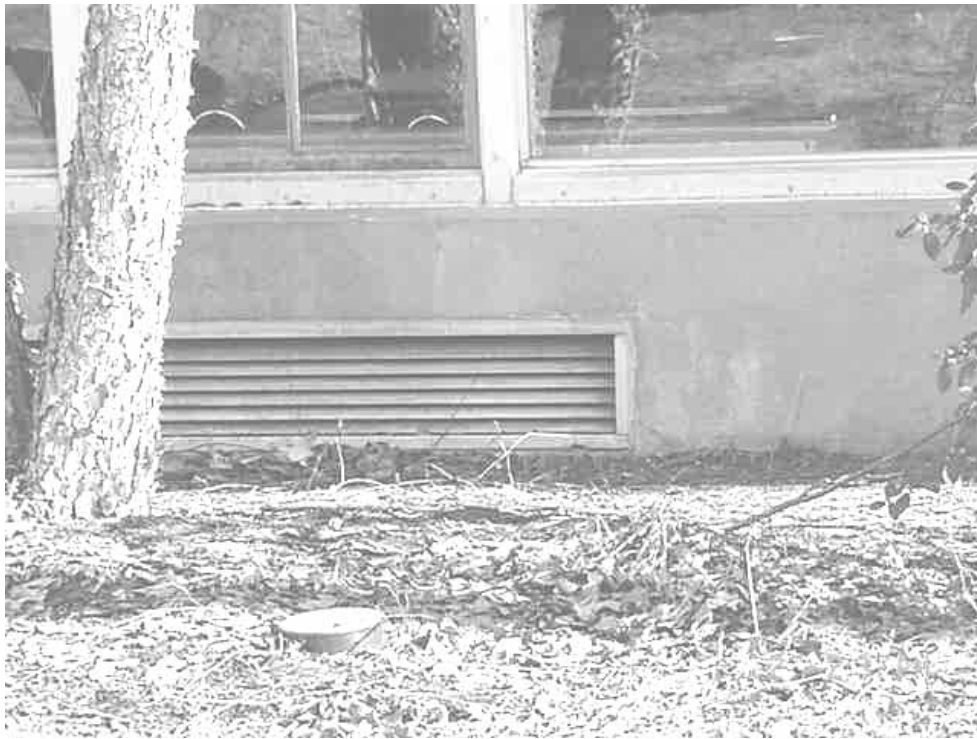
Picture 1

Univent Fresh Air Intake

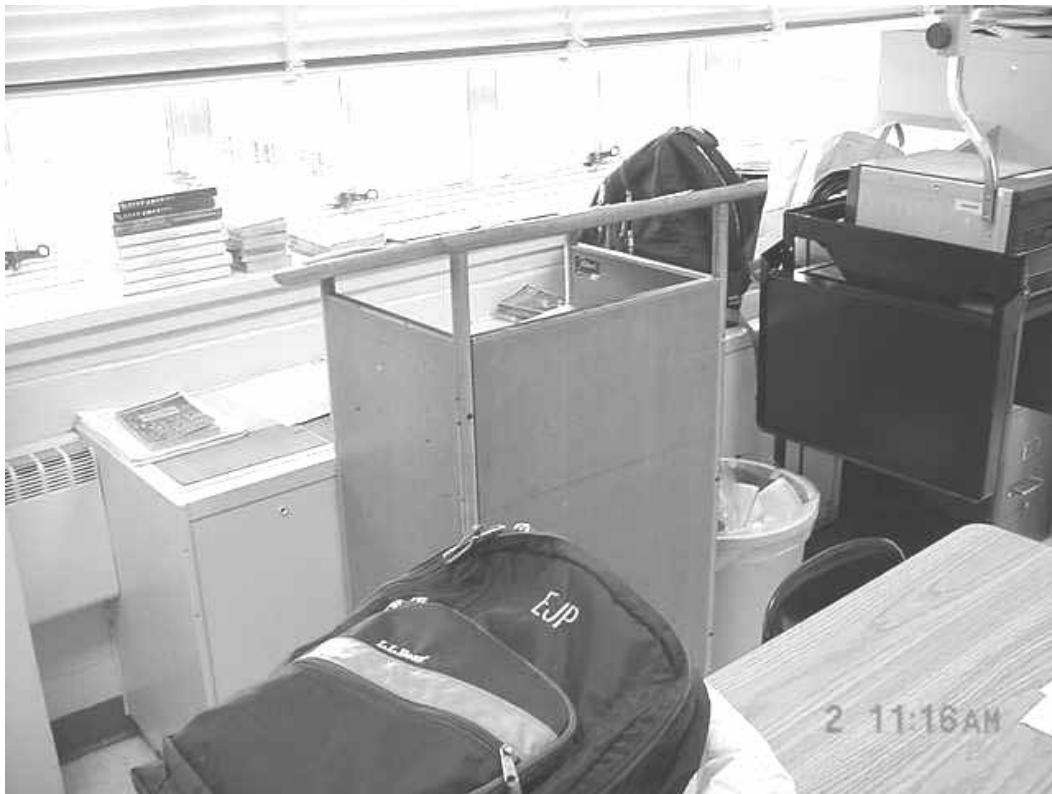
Picture 2

Univent Return Vent Obstructed By Classroom Items

5. Inspect rooftop exhaust motors and belts for proper function, repair and replace as necessary.
6. Remove all blockages from univents and exhaust vents.

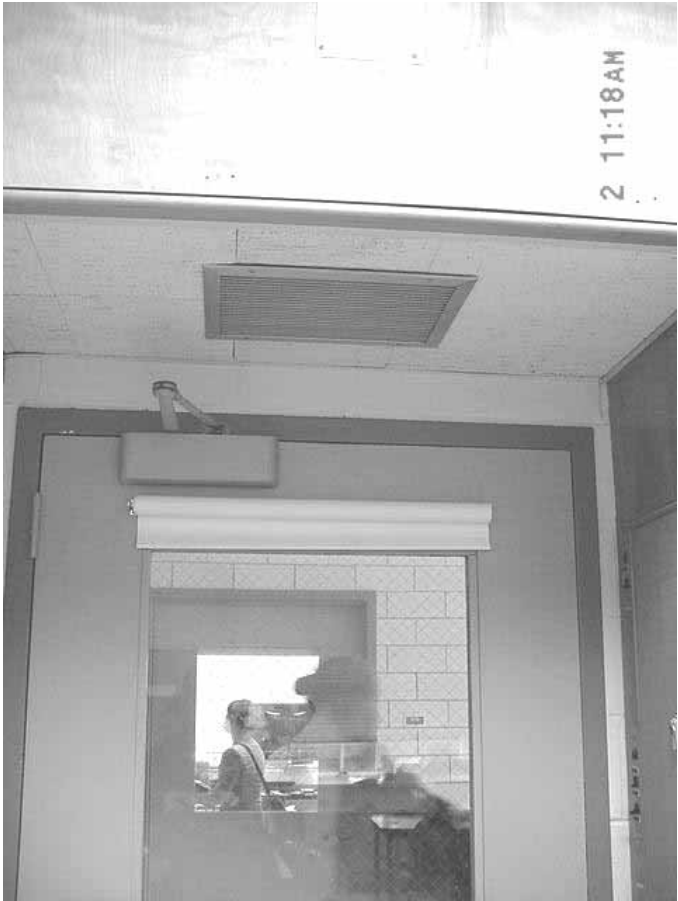
Picture 3

Exhaust ventilation in classrooms consists of ceiling or wall-mounted vents powered by rooftop motors (Pictures 3 and 4). Exhaust ventilation in the 1938 portion of the building is provided by exhaust vents located in ungrated floor level “cubby” holes. These vents were being used for storage throughout the wing, thereby obstructing airflow (Picture 5). The exhaust system was not drawing and/or was backdrafting in a number of areas surveyed, indicating that motors were either deactivated or non-functional. As with the univents, exhaust vents must be activated and remain free of obstructions to function as designed. Without adequate exhaust ventilation, excess heat and environmental pollutants can build up and lead to indoor air complaints.

Ceiling-Mounted Exhaust Vent

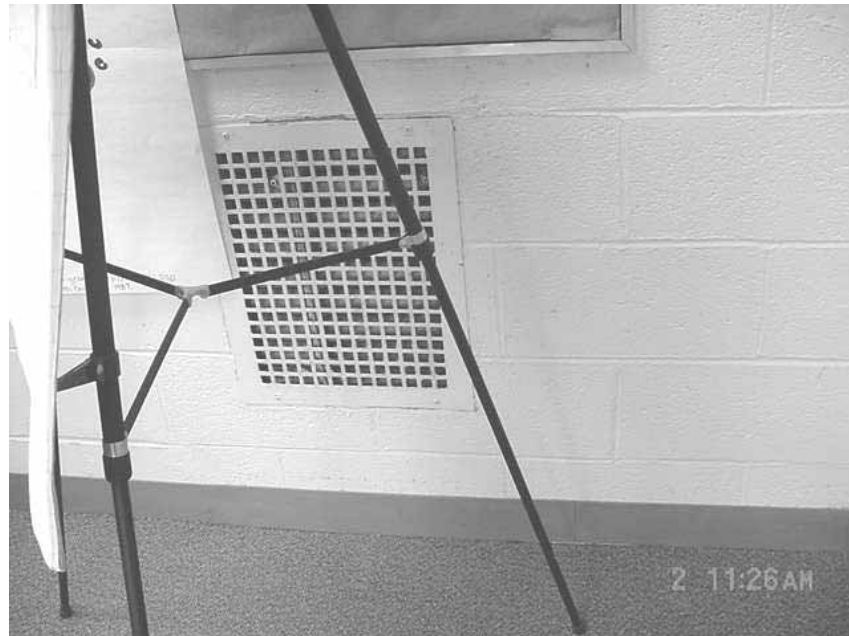
Picture 4

Wall-Mounted Exhaust Vent

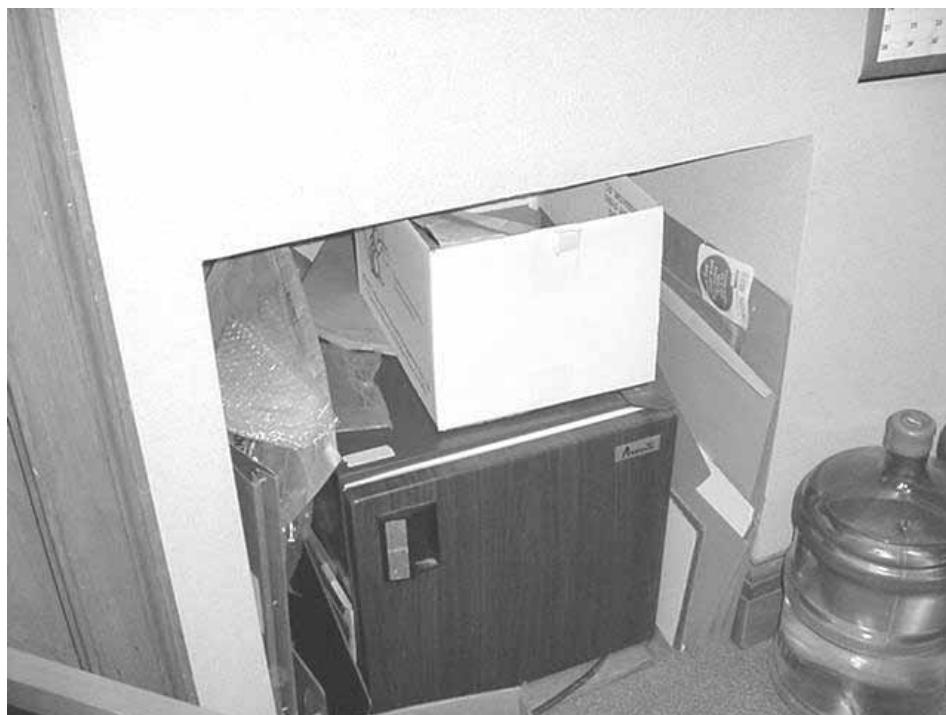
Picture 5

Exhaust “Cubby” Used For Storage in Classroom

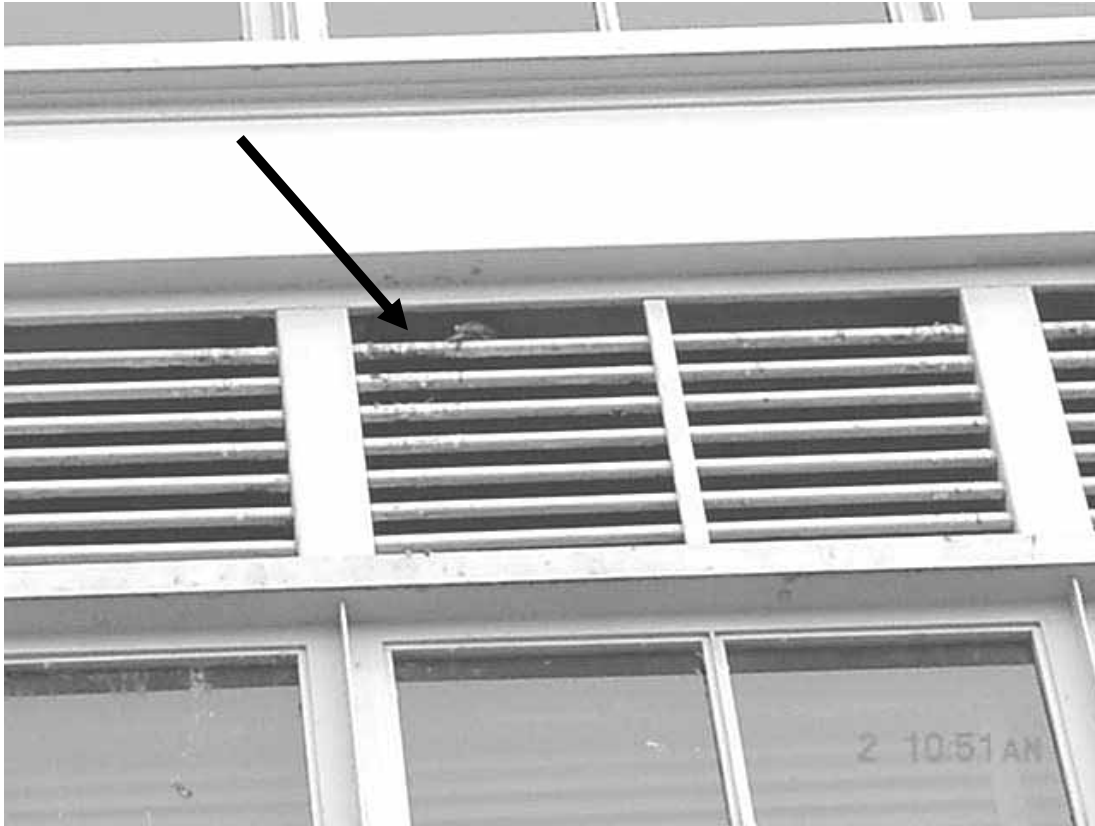
Picture 6

Signs of bird roosting and nesting were observed in a number of recesses around the exterior of the building (e.g., overhangs, building envelope penetrations) (Picture 6). Birds can be a source of disease, and bird wastes and feathers can contain mold, which can be irritating to the respiratory system.

Certain molds are associated with bird waste and are of concern for immune-compromised individuals. Other diseases of the respiratory tract may also result from chronic exposure to bird waste. Exposure to bird wastes is thought to be associated with the development of hypersensitivity pneumonitis in some individuals. Psittacosis (bird fancier's disease) is another condition closely associated with exposure to bird wastes in either the occupational or bird rearing setting. While immune-compromised individuals have an increased risk of health impacts following exposure to the materials in bird wastes, these impacts may also occur in healthy individuals exposed to these materials. The protection of both the cleaner and other occupants present in the building must be considered as part of the overall remedial plan. Where cleaning solutions are to be used, the “cleaner” is required to be trained in the use of personal protective methods and equipment to prevent either the spread of disease from the bird wastes and/or exposure to cleaning chemicals. In addition, the method used to clean up bird waste may result in the aerosolization of particulates that can spread to occupied areas via openings (doors, etc.) or the ventilation system.

Birds and Wastes on Exterior of the Building

13. Contact a pest management consultant firm to remove birds' nests and wastes from the building. To prevent possible exposure to bird wastes, implement the corrective actions recommended by the CDC (CDC, 1998). To prevent possible spread of bird waste particulates to occupied areas, employ the methods listed in the SMACNA guidelines for Containment of Renovation in Occupied Buildings (SMACNA, 1995).

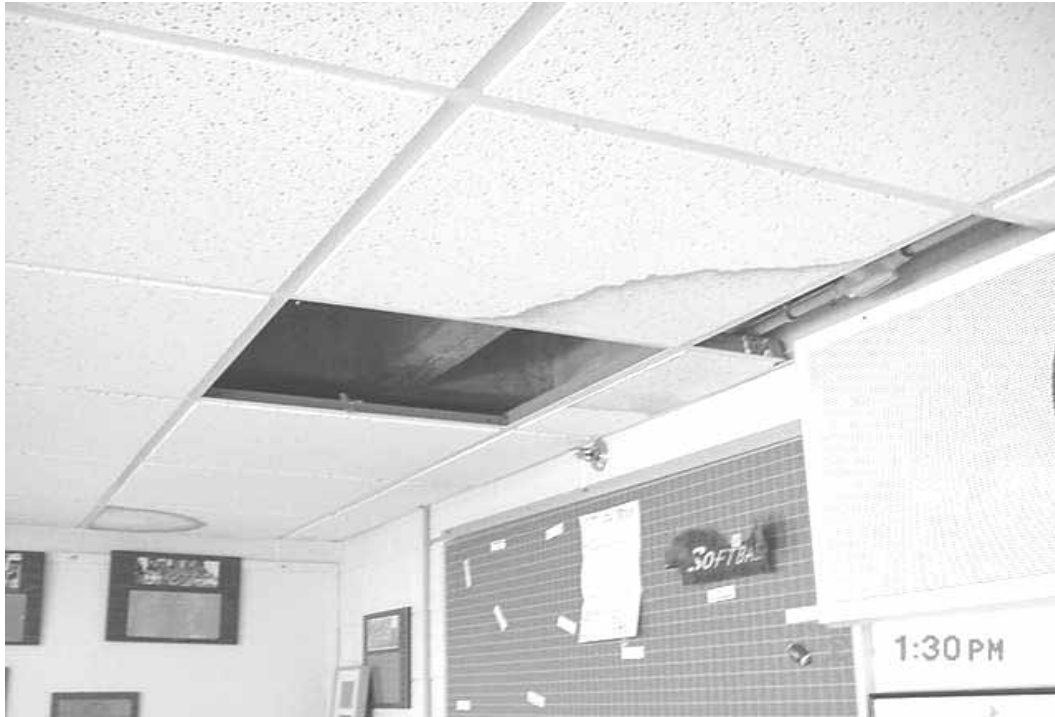
Picture 7

A number of areas had water-stained ceiling tiles, which can indicate leaks from the roof, heating/steam pipes or plumbing system (Picture 7). According Mr. Cotto, the boiler system was replaced a number of years prior to this assessment. Mr. Cotto reported the boilers were connected to the existing heating pipe system. In the experience of BEHA staff, attaching a new boiler plant to an existing pipe system can produce steam leaks through pipe joints due to the increase of efficiency and steam pressure. A number of water damaged or missing ceiling tiles were located directly beneath leaking heating pipe joints. As each joint is repaired, Mr. Cotto reports that another leak occurs in joints in another part of heating system. The repair on the original leak joint then transfers pressure to other parts of the pipe system, which produces a breach at the next weakest joint. Water-damaged porous building materials can provide a source for mold and should be replaced after a water leak is discovered and repaired. Where leaks are noted, removal of water damaged materials is recommended to prevent mold growth.

Missing/Water Damaged Ceiling Tiles

7. Consider having ventilation systems re-balanced every five years by an HVAC engineering firm.
8. Continue to remove water damaged ceiling tiles from the ceiling where steam pipe leaks occur.

1. Leaks for weak joints in the heating system plumbing will continue to occur in the pattern as reported by Mr. Cotto, which would in turn cause damage to the suspended ceiling system and other building components. Consideration should be given to conducting a comprehensive study of the steam distribution system to affect a permanent repair of this system.
2. Continue with plans to replace roof. Ensure all roof leaks are repaired. Replace any remaining water-stained ceiling tiles. Examine the areas above and around these tiles for mold growth. Disinfect areas of water leaks with an appropriate antimicrobial.
3. Local exhaust ventilation should be employed for the various activities noted in the technology shop.

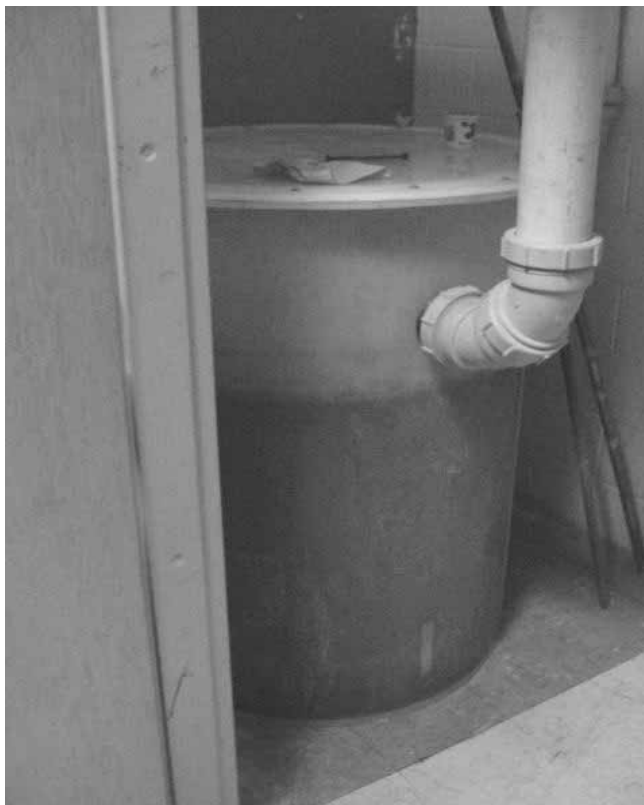
Picture 8

This assessment of the WHS was prompted due to a leak from a tank located in the basement of the building (Picture 8). At the time of this assessment, the leak from this tank had been repaired and the area was cleaned. No residual water damage to building materials or mold growth from this incident was present.

Tank in Basement That Leaked

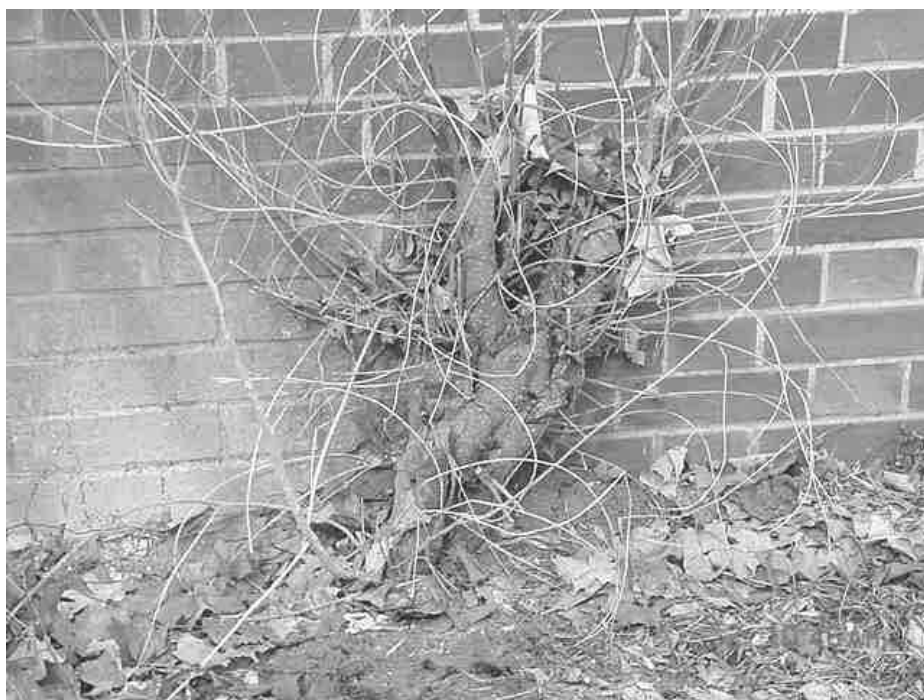
Picture 9

Small trees and other plants were also seen growing against the foundation (Pictures 9 and 9A). The growth of roots against the exterior of foundation walls, as well as spaces between the tarmac, can bring moisture in contact with brick and foundation, which may eventually lead to moisture penetration below ground level areas of the building. The exterior walls had spaces/utility holes in brickwork (Pictures 10 and 11). These conditions are breaches of the building envelope and provide a means for water entry into the building. Repeated water penetration can result in the chronic wetting of building materials and the potential for microbial growth.

Tree/Stump Growing Against Foundation

16. Remove foliage to a minimum of five feet away from the foundation. Trim trees in rear of building that overhang the roof. Ensure univent air intakes on the exterior of the building are free of obstruction.

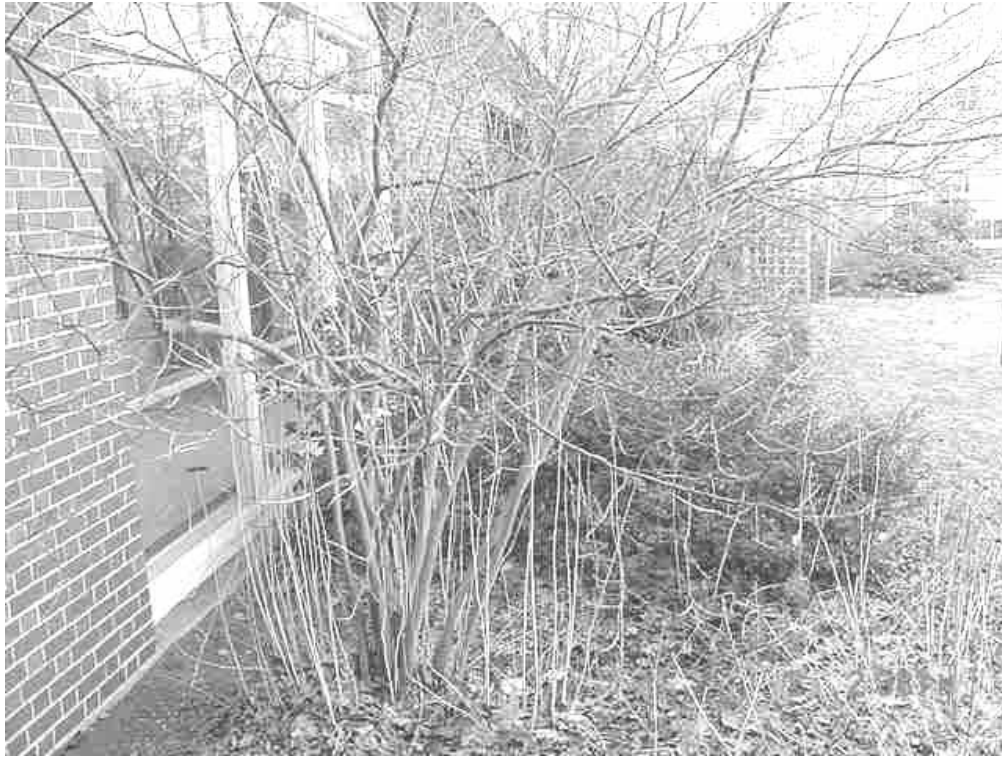
Picture 9A

Trees/Shrubs Growing Against Exterior Wall

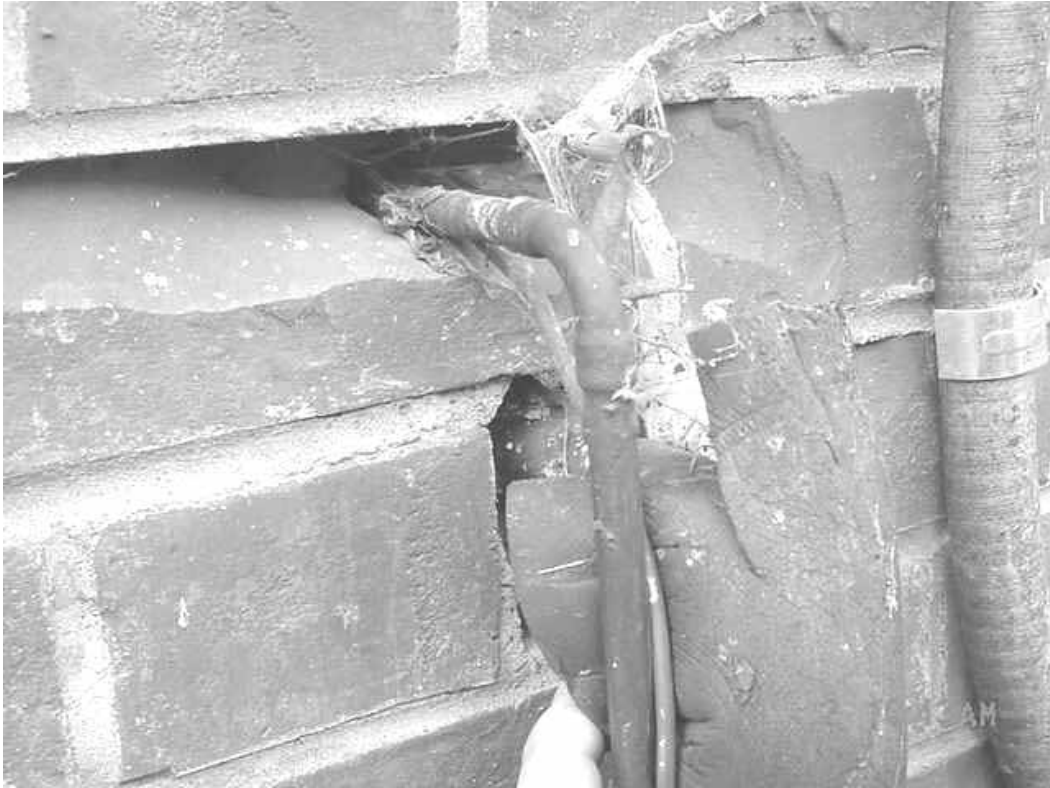
Picture 10

Spaces around Utilities in Exterior Wall

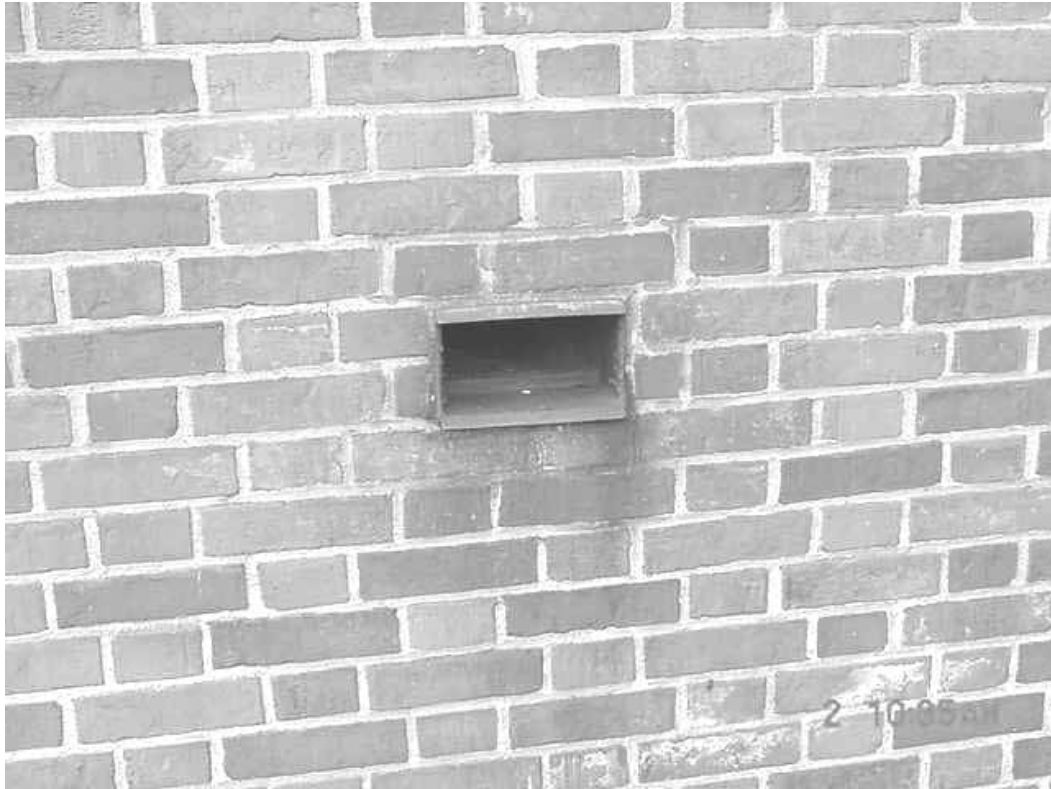
Picture 11

Open Vent To Outside

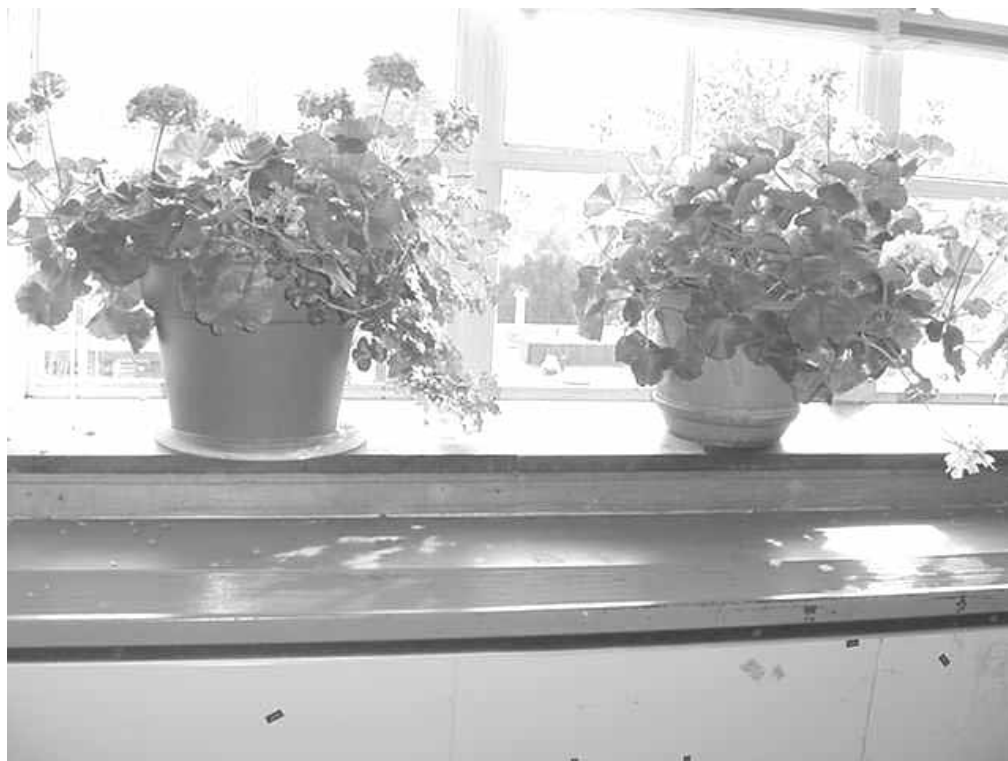
Picture 12

Several classrooms had a number of plants. Moistened plant soil and drip pans can be a source of mold growth. Plants should be equipped with drip pans. Plants are also a source of pollen. Several classrooms had plants in close proximity to univents (Picture 12). Plants should be located away from the air stream of ventilation sources to prevent the aerosolization of mold, pollen or particulate matter throughout the classroom.

Flowering Plants near Univent Air Diffuser

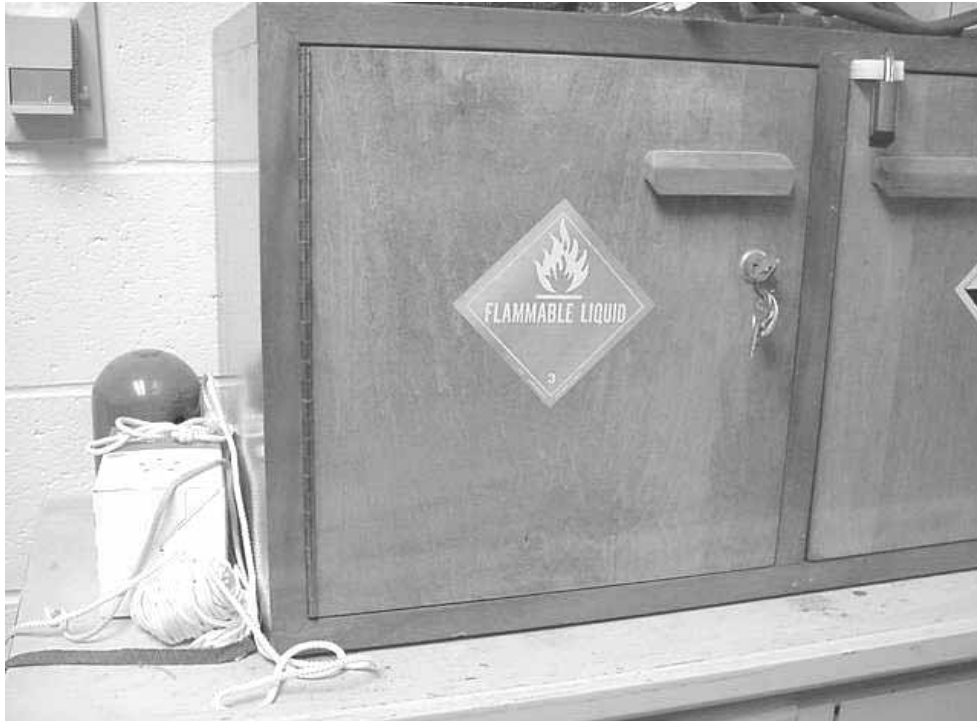
Picture 13

Of concern is wooden cabinet used to store acids that is placed on top of a flameproof cabinet (Picture 13). This configuration of storage cabinets is of concern because a leak of corrosives from the wooden cabinet would likely corrode the metal flameproof cabinet. Acid vapors appear to have escaped from containers stored in this wood cabinet, as evidenced by

heavy corrosion of door hinges, fasteners and locks. Cabinets used to store acidic materials should be constructed of materials that resist corrosion. In addition flammable materials and corrosives should be separate to prevent accidental mixing of these materials. Certain flammables and corrosive mixtures can react violently if mixed.

Mislabeled Wooden Cabinet That Is Used To Store Acids That Is Place On Top Of a Flameproof Cabinet

1. Move the water reactive chemical(s) to an area without pipes or other potential water sources. Label storage area sufficiently to warn of water reactive danger.
2. Remove wooden cabinet on top of the flammable storage cabinet and move acids to a location away from organic chemicals and water. Obtain a corrosion-resistant storage cabinet for storage of acids.
3. Survey classroom univents to ascertain function and determine whether an adequate air supply exists for each room. Consider consulting a heating, ventilation and air conditioning (HVAC) engineer concerning the calibration of univent fresh air control dampers throughout the school.
4. To maximize air exchange, operate all ventilation systems throughout the building (e.g., gym, auditorium, classrooms) continuously during periods of school occupancy

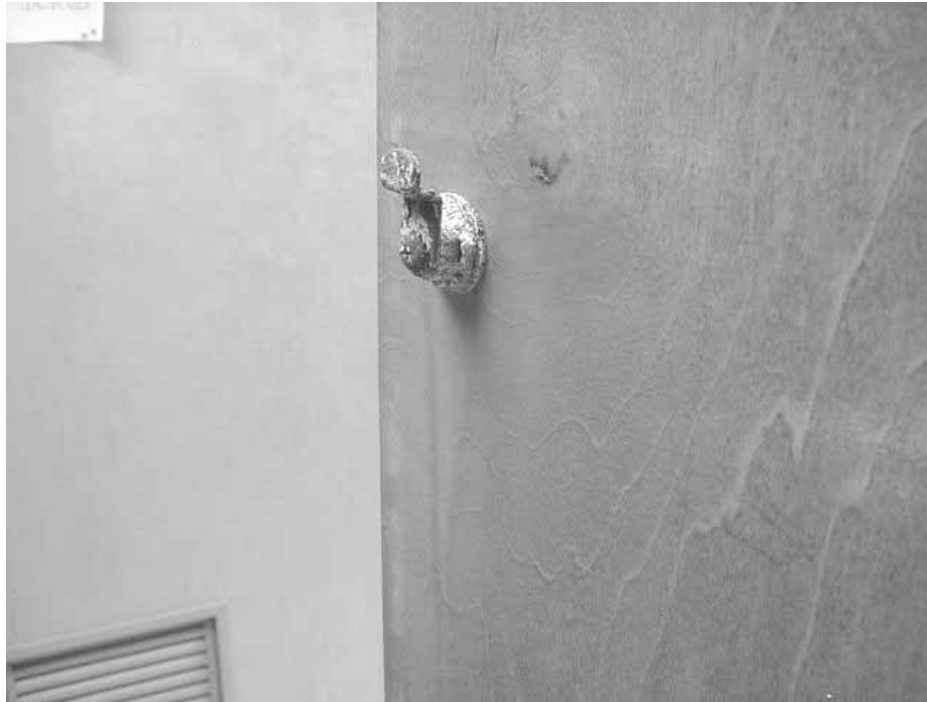
Picture 14

1. Fasteners for shelves and well as metal caps on containers in the chemical storeroom appear to be corroded from off-gassing materials (see Picture 14). Corrosive materials appear to have corroded the metal shelf supports, coating the shelf with oxidized metal. The corroding of the metal shelf supports can lead to the undermining of the structural integrity of the shelves. Corrosive liquid materials should be removed from the shelves and relocated.

Fasteners in N the Chemical Storeroom Were Corroded From Off-Gassing Materials

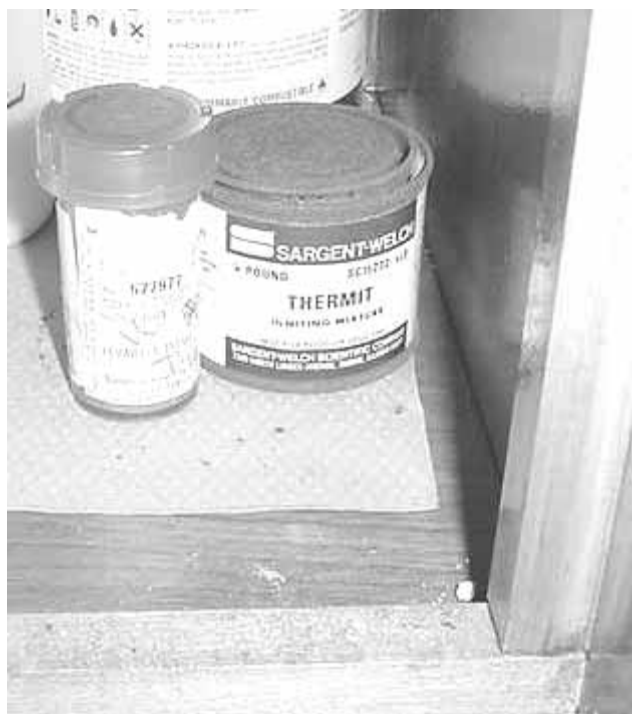
Picture 15

A Highly Flammable Material, “Themit”, Was Stored On an Open Shelf

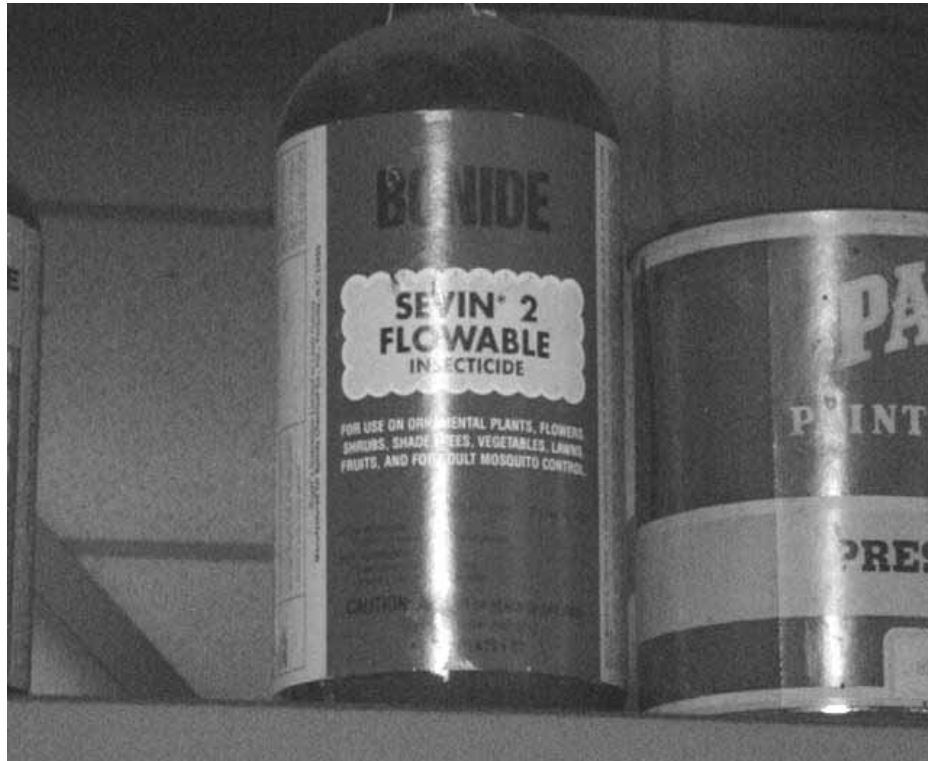
Picture 16

A restricted use pesticide was noted in an area used to collect chemicals for disposal (see Picture 16). Sevin is a carbamate pesticide that can cause serious acute health effects upon exposure and can be readily absorbed through the skin on contact (USEPA, 1989). For these reasons, the US Environmental Protection Agency has classified sevin as restricted use pesticides, which curtails the sale of these materials to the general public and requires that the user of these materials be a licensed restricted use pesticide applicator. Under current Massachusetts law (effective November 1, 2001), the principles of integrated pest management (IPM) must be used to remove pests in state buildings (Mass Act, 2000). Pesticide use indoors can introduce chemicals that can be sources of eye, nose and throat irritation.

Pesticide Container in Storeroom

It is highly recommended that a thorough inventory of chemicals in the science department and custodial areas be done to assess chemical storage, reduce amounts of chemical s stored and dispose in an appropriate manner consistent with Massachusetts hazardous waste laws.

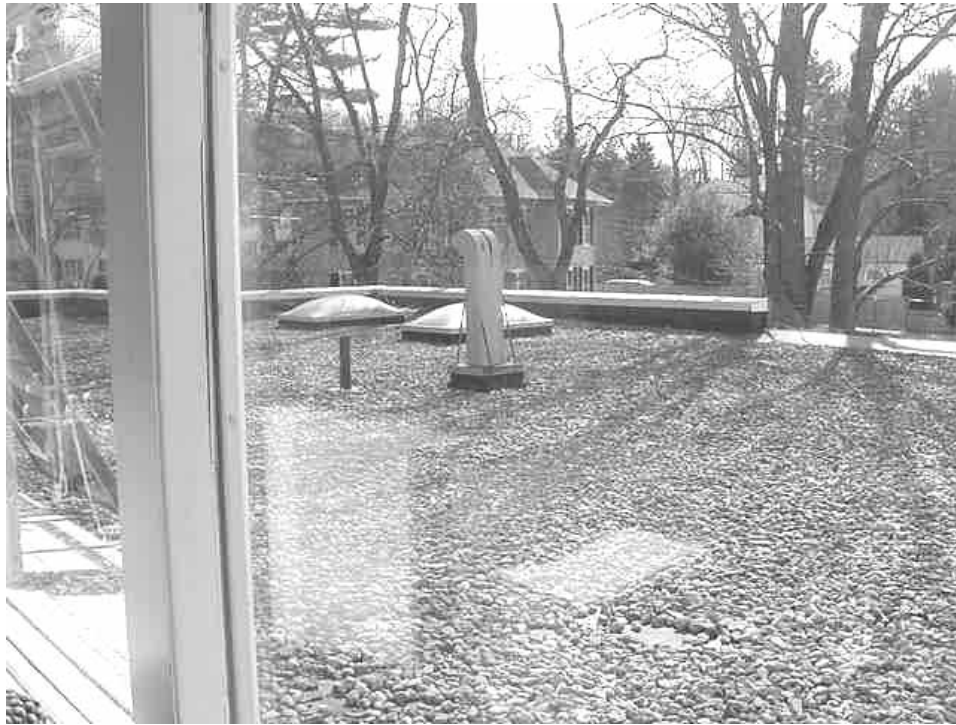
Picture 17

BEHA staff received reports of odors in a classroom (193) above the woodshop. The fresh air is supplied by univents with fresh intakes at the level of the roof above the woodshop. The exhaust vent for the wood shop terminates in a cane vent on the same roof (Picture 17). The location of the cane exhaust vent can lead to vapors and odors from the wood shop to be directed into the classroom univent intake under certain wind conditions. Odors from wood shops and include wood dust and a variety of volatile organic compounds (VOCs) for paints, varnishes and other carpentry related materials. VOCs and wood dust can be irritating to the eyes, nose, throat and respiratory system.

Roof above Wood Shop
